**SAMPLE REPORT — TURBOCHARGER FAILURE**

REPORT PREPARED FOR:  
EXAMPLE FLEET SERVICES (PTY) LTD

| VEHICLE | PASSENGER CAR<br>(EXAMPLE) |

REPORT BY:  
ASWANAI (PTY) LTD  
14 SEPTEMBER 2026

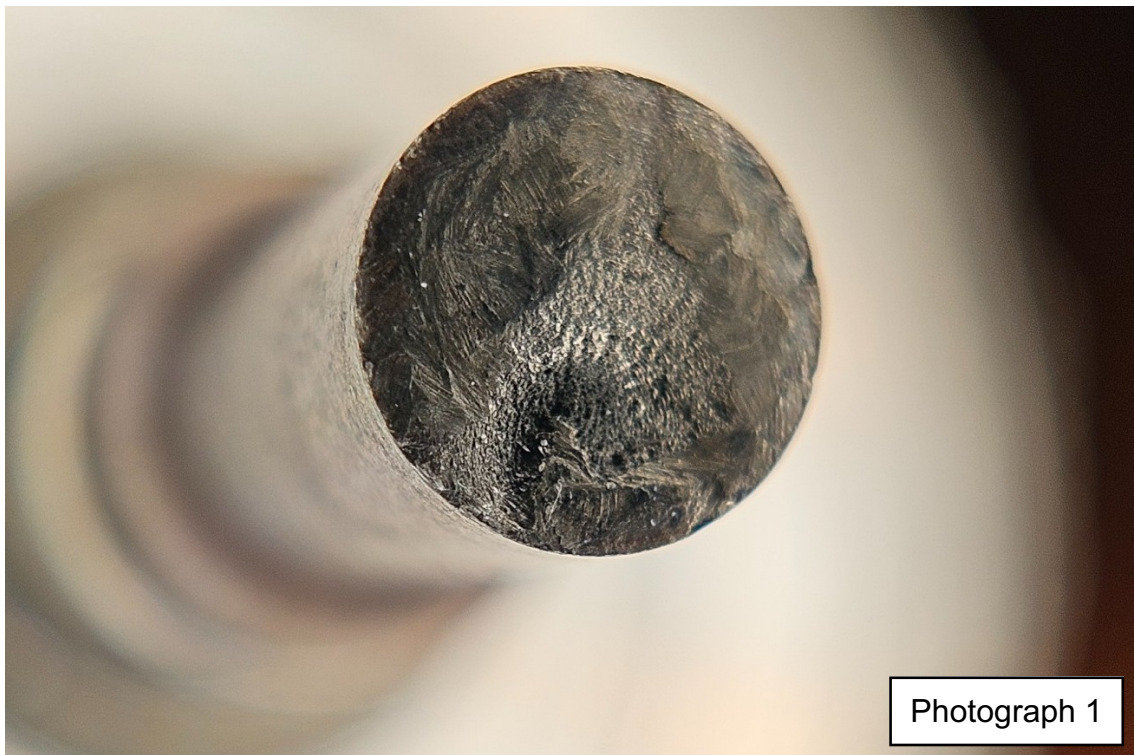
Photograph 1

The shaft had fractured at the reduced section immediately inboard of the turbine-end journal, as seen in photograph 1. The fracture face was transverse and coarse, consistent with a fast final fracture; a finer-textured zone at one side of the edge could not be resolved at photographic scale.

The reverse order — a fatigue crack in the shaft first, the bearing distress after — is not excluded on photographs alone and is carried as a live alternative until the fracture face is examined under a microscope.

- Examine the fracture face under a scanning electron microscope for fatigue marks, to settle whether the shaft cracked before or after the bearing failed.
- Review the vehicle's oil service record, oil pressure and shut-down practice, and fit the replacement turbocharger only after the oil feed has been checked.

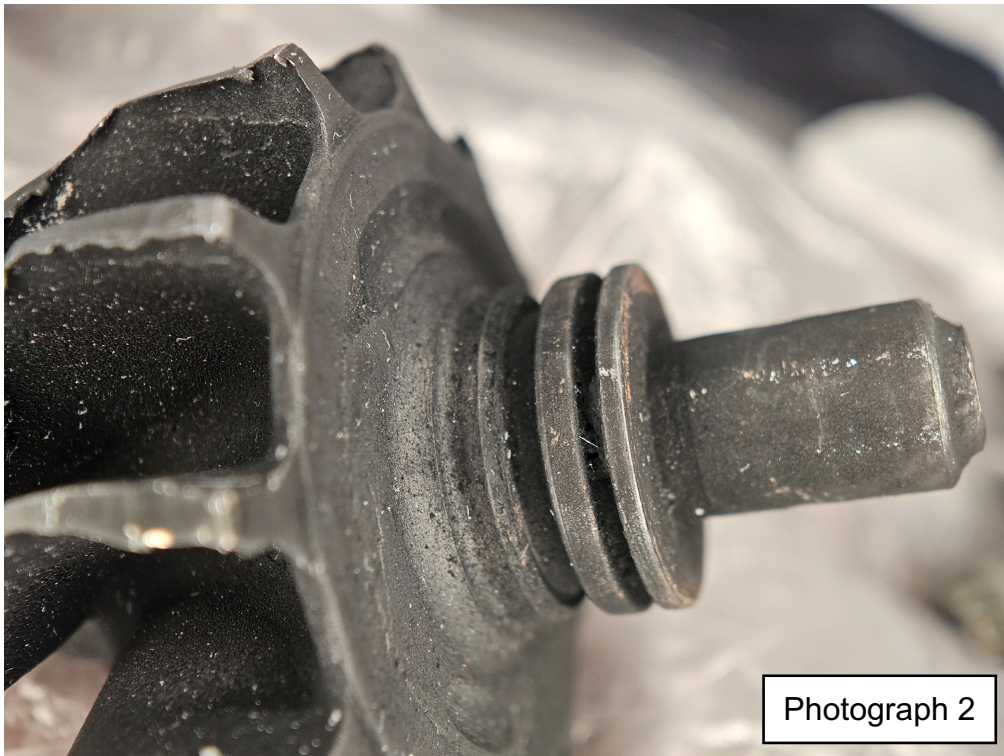
The turbine wheel retained a stub of the shaft, showing that the weld between wheel and shaft was intact, as seen in photograph 2. The stub was sooted black with hard lacquer on the seal land, showing that oil in this region had been exposed to high temperature.

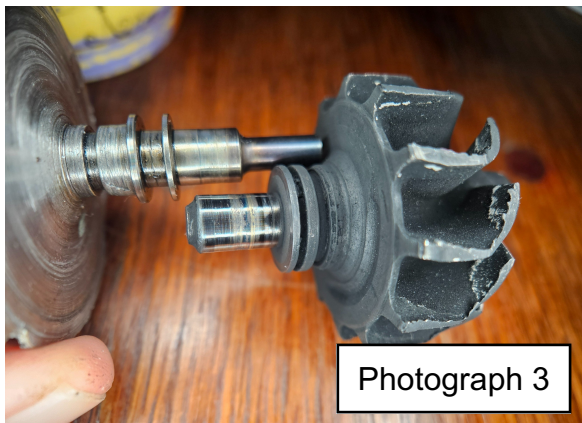
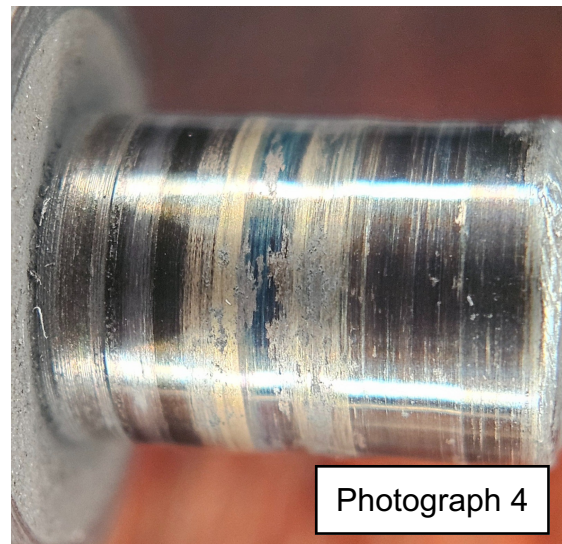
The turbine-end journal carried blue and straw temper colours with fine circumferential scoring, and bands of copper-coloured material running right around the journal, as seen in photographs 3 and 4. The customer, with the part in hand, identified this material as smeared metal, consistent with bronze transferred from the bearing bush; a simple spot test for copper would confirm it.

When the film is lost, the bronze of the bush smears onto the journal and temper colours form on the steel. Even bands right around the journal show that the contact happened while the shaft was still whole and turning; a shaft that whirls only after it has broken gouges locally instead.

Both journals draw their oil from the same feed, so contaminated oil scores both ends; damage confined to the hot turbine end points to a heat-driven loss of the oil film. Tip damage all round a wheel is the pattern of a rotor that has lost its running position, not of a foreign object, which strikes only a few blades.

The oil film at the turbine-end bearing was lost and the bush ran metal-to-metal against its journal. The rotor then lost its running position, both wheels struck their housings, and the shaft fractured at the reduced section beside the failed bearing.

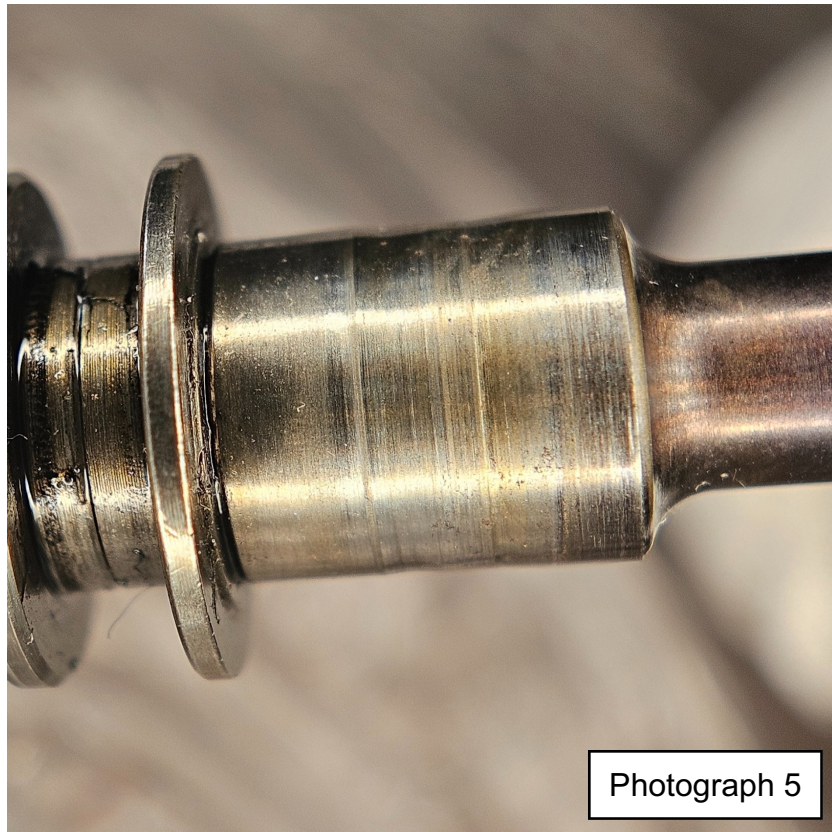
Photograph 5

The compressor-end journal was bright and unmarked, as seen in photograph 5. The running distress was therefore confined to the turbine end.

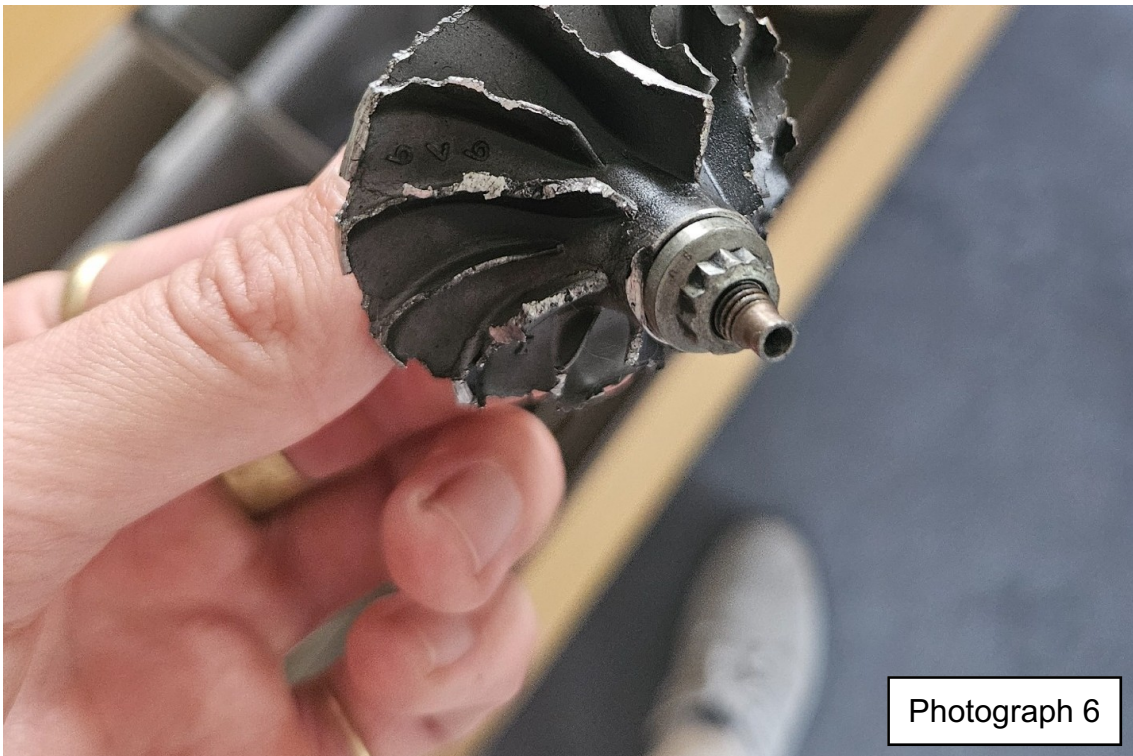
Photograph 6

The compressor blades were torn away at their tips around the full circumference of the wheel, as seen in photograph 6, consistent with the blades rubbing the housing while the rotor was turning.

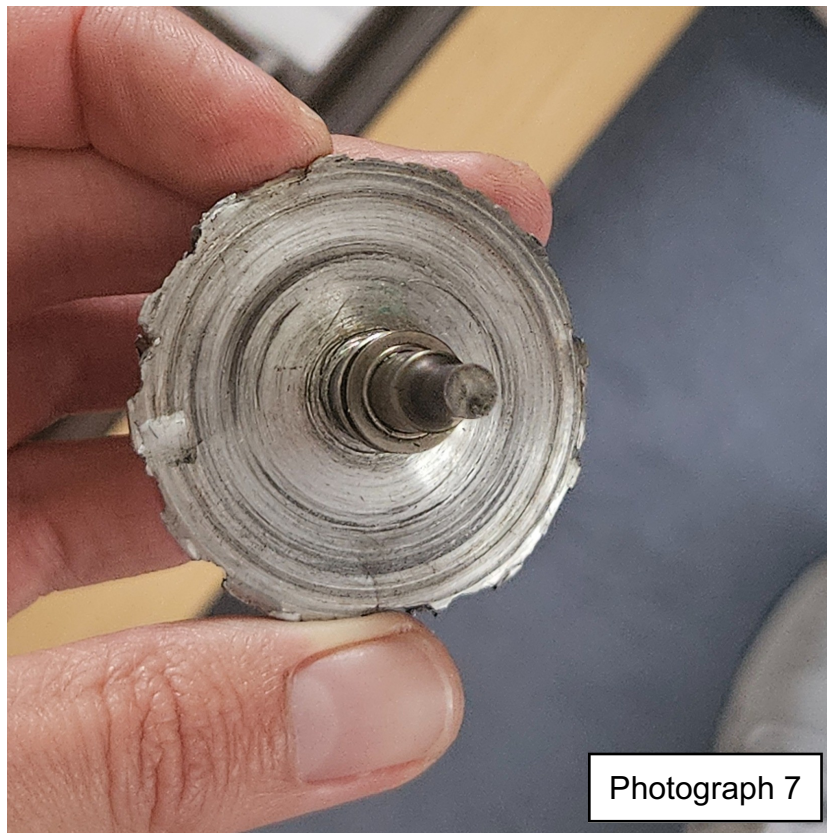
The back face of the compressor wheel carried heavy circular rub marks, as seen in photograph 7, showing that the rotor had also moved along its axis and rubbed the backplate.

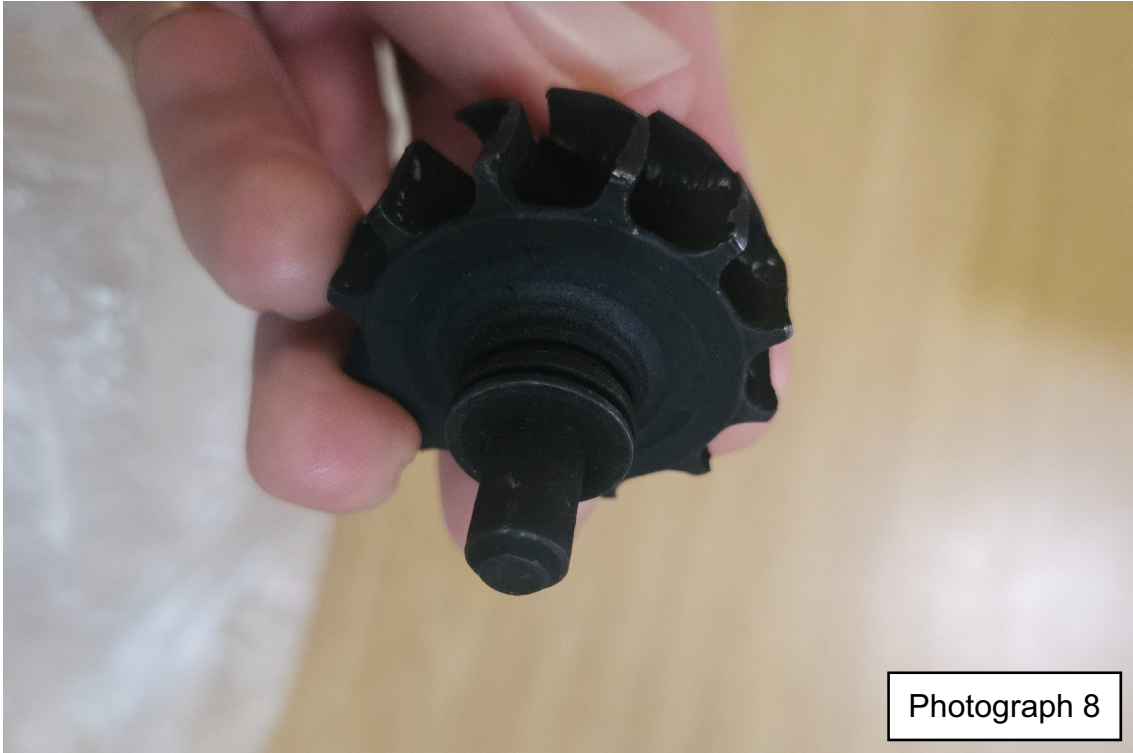
The turbine wheel blade tips were likewise broken around the full circumference, as seen in photograph 8.
